This is the fourth article of a 15-part series on the GLOF research and mitigation project between May 2009 and March 2012. The articles will highlight latest findings on glacier, glacial lakes condition and natural hazards in the Bhutan Himalayas. Experts from the department of geology and mines (DGM), Japan International Cooperation Agency (JICA) and Japan Science and Technology Agency (JST) are involved with the project.

# Glacier districts in Bhutan

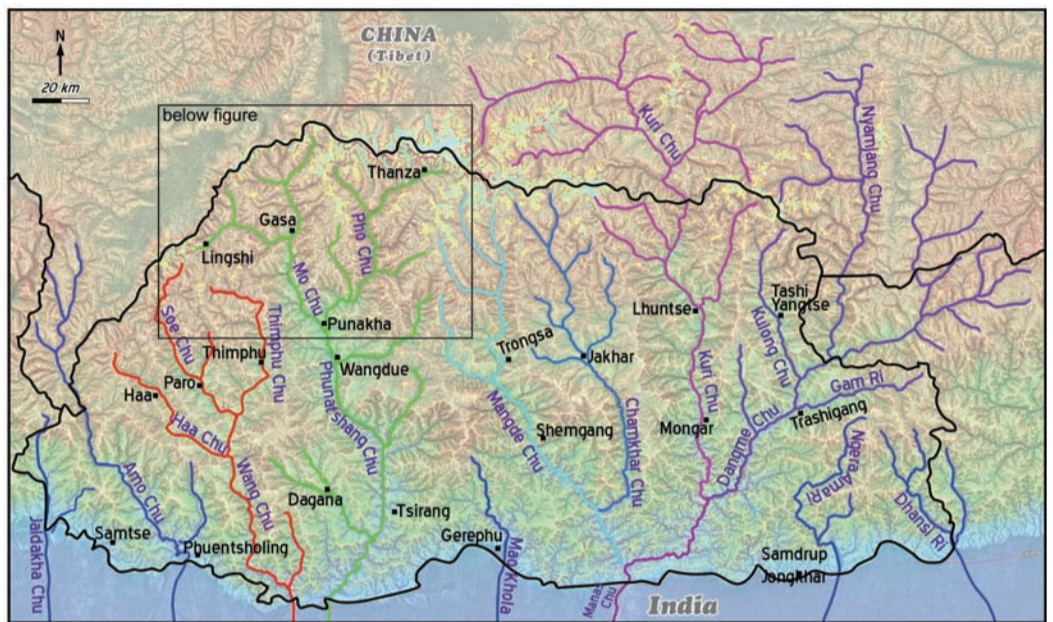
small fractions of such natures, especially the condition of glacial lakes in the six major watersheds in coming four weeks. The target basins are; the upper Paro Chu (Soe Chu, red line in the right upper figure), Punatsang Chu (green line), Mangde Chu (light blue line), Chamkhar Chu (dark blue line), Kuri Chu (light purple line) and Dangme Chu (dark purple line). As for today's topic, I will illustrate the upper streams of parents river, that is Pho Chu and Mo Chu, which join together at the front of Punakha Dzong.

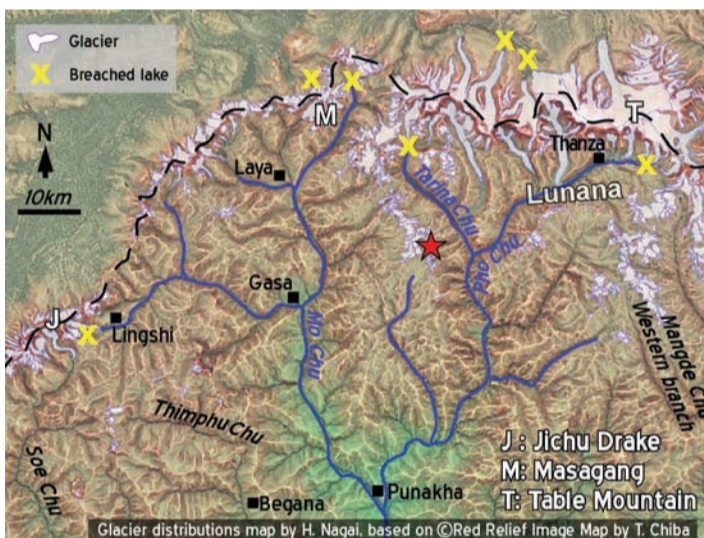
The altitudes around peaks and ridge of the Himalayan range (Chinese border) are 6000 to over 7000 meter above sea level. The white patches in the right lower figure indicate the distribution of the glaciers in the northern Bhutan (drawn by Mr. Hiroto Nagai, Nagoya University). Most of the glaciers are located along the border and the dividing ridge between Tarina Chu and Mo Chu (north of a red star in the lower figure). The size of each glacier in the northeast of Pho Chu is relatively-large. In the satellite images, some of them may look

like neckties. These large neckties although not really white, are over 10 km long and over 1 km in width. The upper Thanza village, or the east of these neckties, three typical and large glacier lakes; Luggye, Thorthormi, and Raphstreng Tsho, are adjacently occurred. These are sometimes called "Lunana complex". The well-known GLOF mitigation project by UNDP GEF/DGM is ongoing at the Thorthormi Tsho from 2009. The west of Thorthormi, the terminal moraine of Raphstreng Tsho also was artificially trenched along the outlet in the late 1990s by Bhutan/India collaboration for the disaster

We furthermore conducted the lake depth surveys on the two lakes near Gangju La pass (red star in the lower figure and an upper photograph), which have been considered as two of the 25 potential dangerous lakes. According to our survey result, both lakes have showed stable condition and unlikely to cause dam breaching.

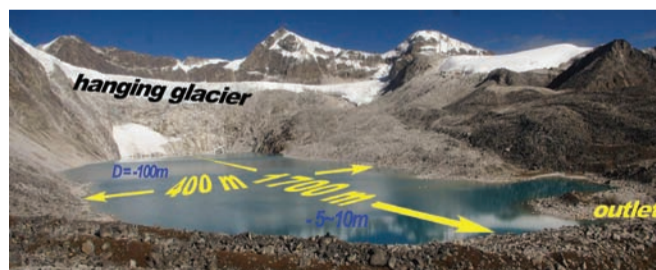
The surveyed glacier lake in the north of Gangju La. The condition seems to be safe, because the water depth near the outlet is shallow.

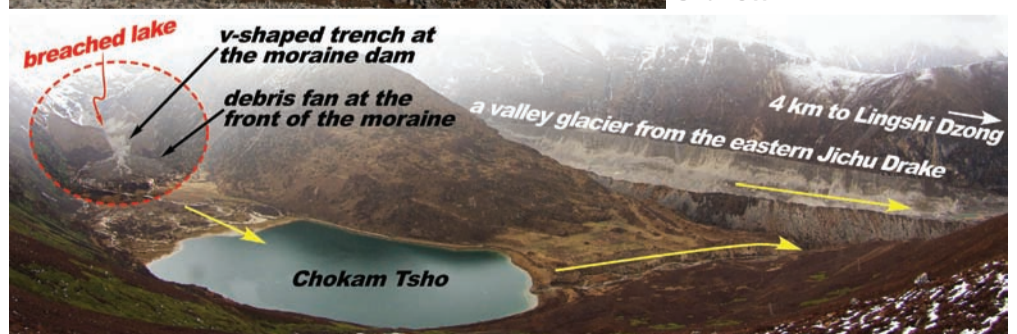
The past case of outburst near Lingshi Dzong. The event was at least before the mid-1960s.
